DEL PINO – Golf and Resort

: DEL PINO Golf and resort is the one of biggest family and business resort which is located in Korea national park Seorak mountain and near East Sea of

With its recent renovation, They replaced their CCTV system from existing analog to WEBGATE HD-CCTV system so that they can monitor and control vacationers safety and resort facility on sight with 220 pcs of HD-SDI cameras.

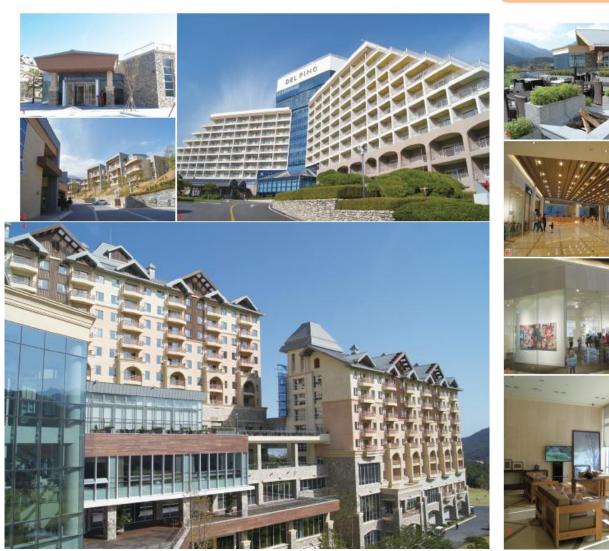
Pic 5,6,7,8 – Golf club house lounge and Fine Arts pavilion and Café and Wine terrace in DEP PINO Golf and Resort **Pic 9,10,11,12 –** In Central Monitoring Room of DEP PINO, they can monitor all spots with 80 pcs of monitors and 4 main monitors. 36 pcs of WEBGATE HD-SDI 8ch DVR were installed.
